EnergyMGT Services

Case Study: Air Handling Unit Failure.

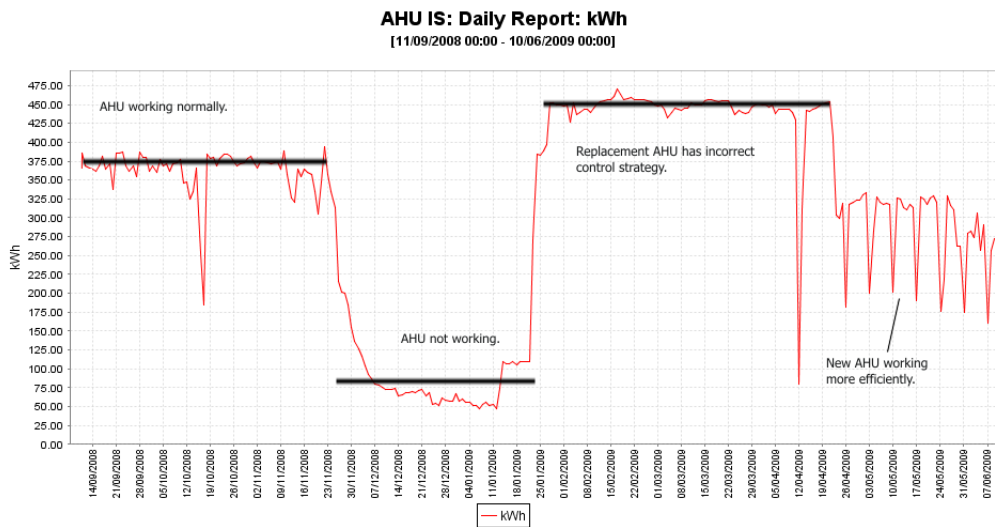
The graph below shows the daily kWh of a single Air Handling Unit. As can be seen, the unit is initially performing as normal, but then malfunctions. This change in profile shape on the graph alerted the customer to the problem – which was subsequently rectified.

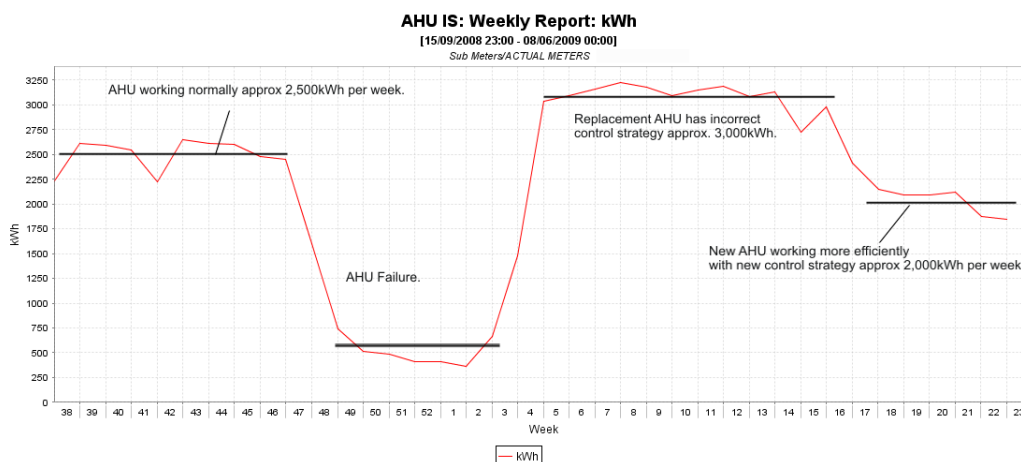
However, the same report also showed that the new AHU was consuming significantly more consumption even though it was supposedly a more energy efficient modern unit. Upon investigation, it was discovered that the control strategy was set up incorrectly. After another site visit the control logic was corrected, the following graph clearly shows the effect of this.

Without EnergyMGT’s sub metering reports, this issue would not have been detected. Detecting the new AHU had incorrect control strategy has saved the client approximately 52,000 kWh/year (approx 28 tonnes of CO₂/year) at just one site.
